# 2. International Symposium on PLANT HEALTH IN URBAN HORTICULTURE

## **THERMOGRAPHY**

a truly non invasive method to detect cavities and rot in trees (roots, trunk and branches) at a distance and from the ground

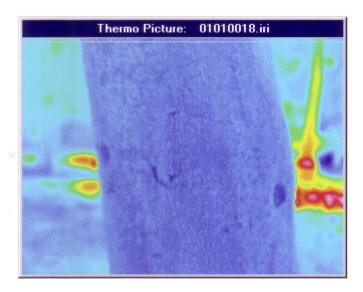
Figure 2 - A healthy lime tree (*Tilia* spp.): the uniform distribution of grey is observed. The dark stains at the top are the thermal images of leaves.

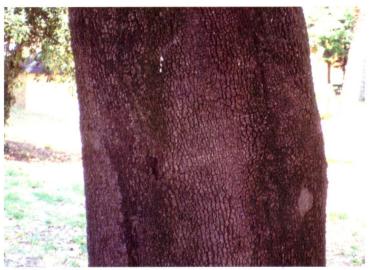
Figure 3 – The thermogram seems to show some small-size damage rendered in dark blue in this cedar (*Cedrus* spp.), but the tree is healthy instead. In fact the exam of the picture of the same area, shot at the same moment, shows the presence of surface damage (slight decortications and patches of detached bark). The need to always observe the surface of the tree under examination and not to interpret the thermogram without the relevant picture available of the tree is clear.

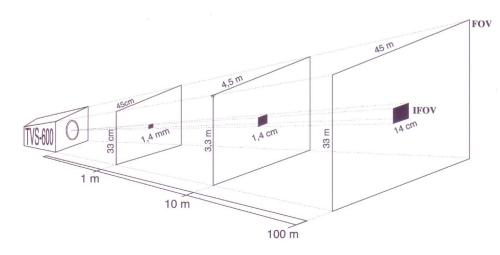
Figure 4 – Geometrical resolution (Instantaneous Field of View – IFOV) and Field of View (FOV) of the apparatus now used for assessments, on the basis of the distance from the object examined.

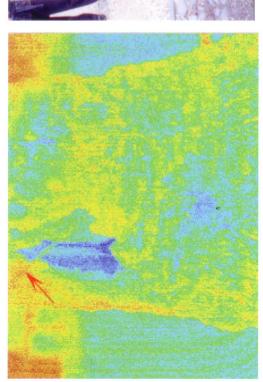
Figure 5 – This palm tree (*Phoenix canariensis*) presents a cavity in the trunk. The size of the cavity cannot be measured because of its shape and the debris present in it. The thermogram allows outlining the size of the cavity, in light blue and green, that was checked with the probe indicated by the red arrow.

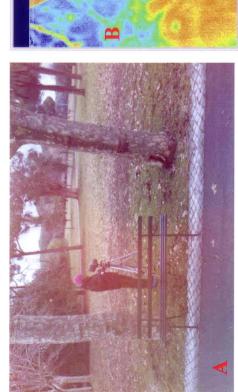
The water absorbs the infrared radiation, therefore assessments cannot be carried out in the rain or on wet tree parts (Figure 6B).

Figure 6 - A This plane-tree (*Platanus hybrida*) is being assessed with the IR camera: the tree has a straining on blue). The root system looks undamaged. The first damage was checked by hitting the trunk with a hammer, the exposed; at the top of the wound, a small cavity going upwards is noticed. B This thermogram, shot at the fork, existence of internal damage at the height of the wound, and how damage moves upwards, near the surface (in interpretation of the thermal image. C This thermogram, filmed at about 90° to the left of the first, shows the the trunk, due to the rain that fell in the previous days. The base presents an oval wound with healthy tissue shows how liquid water is rendered in a colour different from the rest of the trunk, thus disturbing the second with a probe.

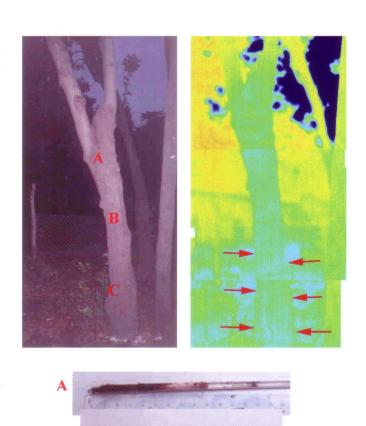
Figure 9 – This bay tree (*Laurus nobilis*) only shows a small cavity full of debris, near an old cut at the fork level. The relevant thermogram shows serious damage in blue and dark green from the base to the fork. The two residual branches are not so damaged. The thermogram of the trunk base was marked with the help of arrows, because inexperienced observers might have mistaken it for the background. The presence of damage was carried out with a Pressler's auger. The points in which the auger was introduced and the relevant cores are indicated by the same letter. A The auger penetrated for 10cm before failing to grip tissue, which means that a cavity or badly damaged tissue were present; water flew out of the hole. **B** The auger penetrated for 10cm before failing to grip tissue, but no water came out of the hole. C The auger failed to grip tissue after penetrating for 20cm.

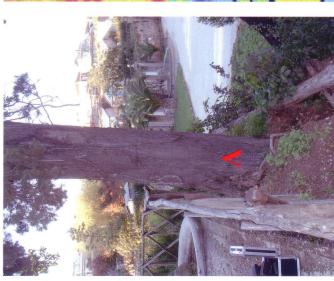
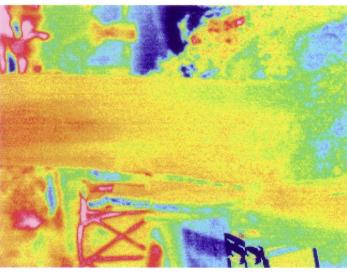
Figure 10 - A cypress (*Cupressus sempervirens*) the thermography of which shows small-sizedamage at the base, especially in the right part of the trunk (in light-green). The control was performed with a Pressler's auger, introduced in the point indicated by A. The exam of the core shows slightly damaged tissue only in the early centimetres beneath the bark.

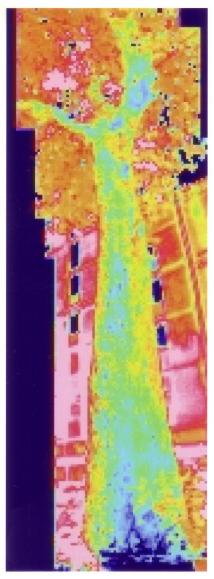
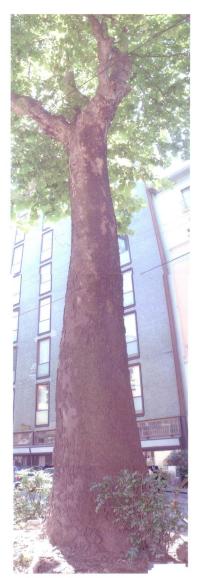
Figure 12 – This 27 m-high plane tree shows signs of damage at the fork level that is difficult to quantify from the ground. The use of Thermography to assess aerial damage was required. Thermograms show how damage affects both branches towards observers and the bifurcation (in blue and lightblue). The analysis of the rest of the tree showed damage in the root system. At the base of the tree on the right it can also be observed how the thermal image of the limbs of the bush (in yellow and orange) hinders the reading of the thermogram.

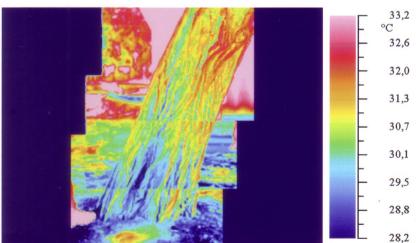
Figure 13 – A pterocaria (*Pterocarya*) growing nearby a school which inclined towards the building. The tree shows damage only at the fork due to the felling of a large branch. Thermography reveals (in dark blue, blue and yellow) wide damage at the root system, particularly on the left side of the image. The damage goes up to the fork but with lesser intensity. At the moment of the survey no mushroom was found. A quick survey found a ganoderma (*Ganoderma* spp.) at the base of an adjacent smaller dead pterocaria.

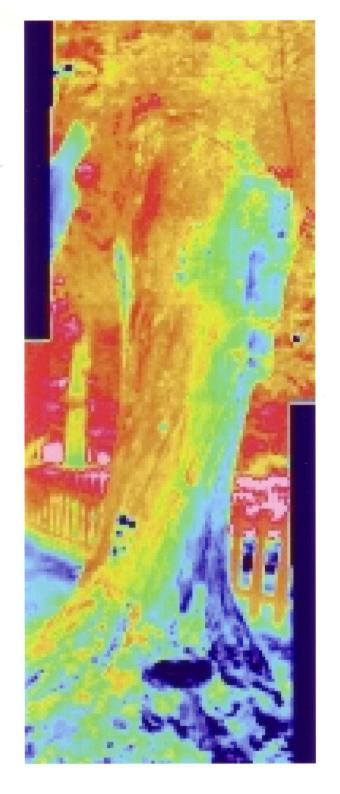
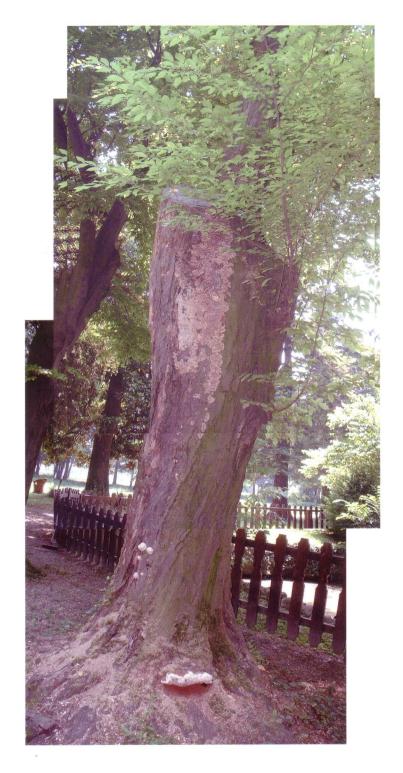
Figure 14 – This hornbeam (*Carpinus betulus*) shows the cut of two of the three branches, right above the bifurcation: the remaining branch has a scrubby vegetation. The stump towards the observer is dead, as shown by the thermogram (in red and yellow) and the saprophytes present. The thermogram also shows that the stump opposite is still alive, but greatly damaged, like the trunk base (in dark blue and light blue). The damage also affects the root system. At the base of the trunk various specimens of ganoderma (*Ganoderma* spp.) can be observed: a huge specimen towards the observer and other small ones on the left of the trunk.
